APPENDICES TO FLOW PUBLIC COMMENTS ON THE JOINT APPLICATION OF ENBRIDGE ENERGY TO OCCUPY GREAT LAKES BOTTOMLANDS FOR ANCHORING SUPPORTS TO TRANSPORT CRUDE OIL IN LINE 5 PIPELINES IN THE STRAITS OF MACKINAC AND LAKE MICHIGAN [2RD-DFDK-Y35G]

Enbridge was violating Line 5 easement for years, documents show

Enbridge document shows years of noncompliance for pipeline supports

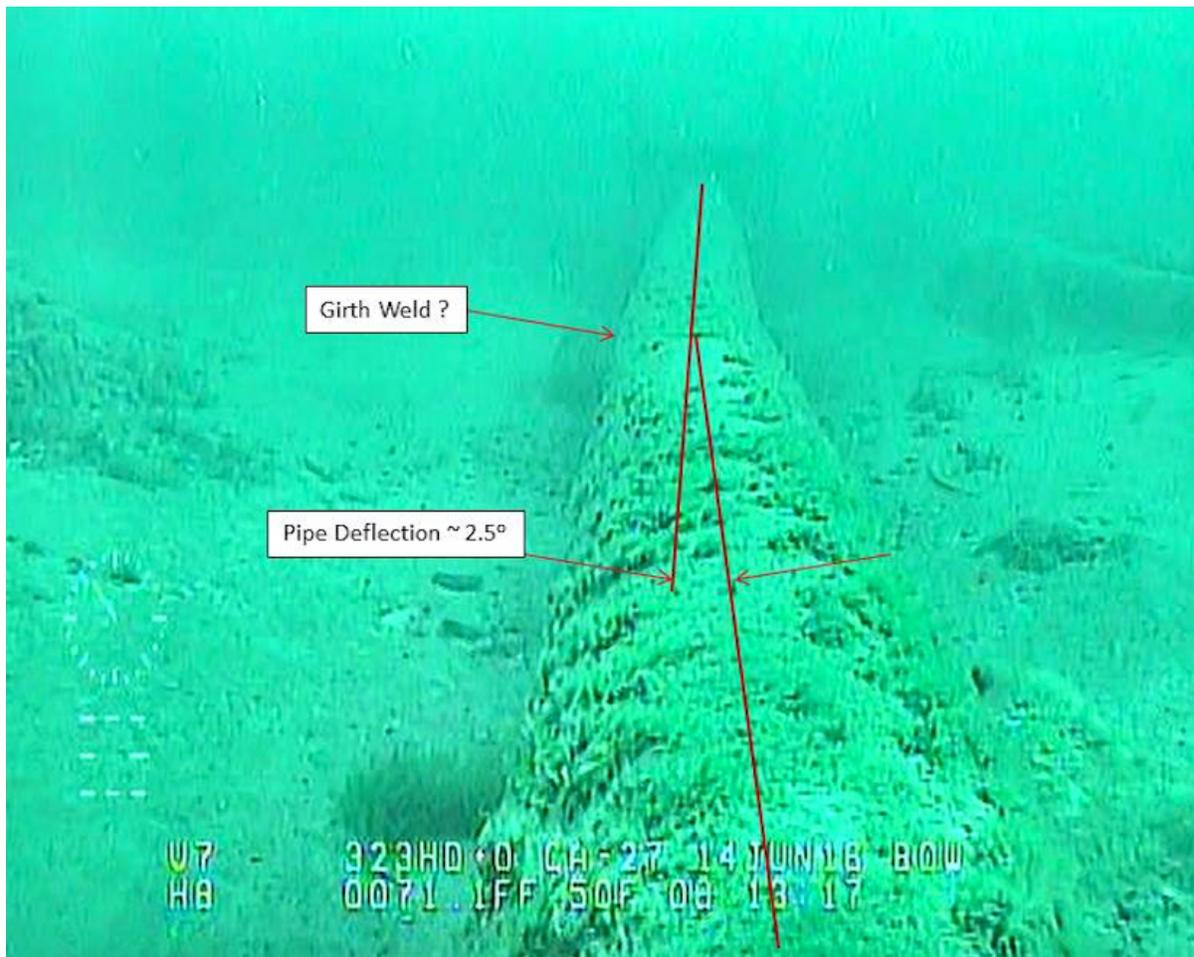
Screenshot of the west leg of Enbridge Line 5 under the Straits of Mackinac that appears to show an area of bent pipe. Image from a June 2016 inspection.

Upon reviewing the June 2016 inspection video, Timm says there appears to be a section of the west pipe that is noticeably bent laterally.

Timm thinks the pipeline is "one peak current event" away from failure.

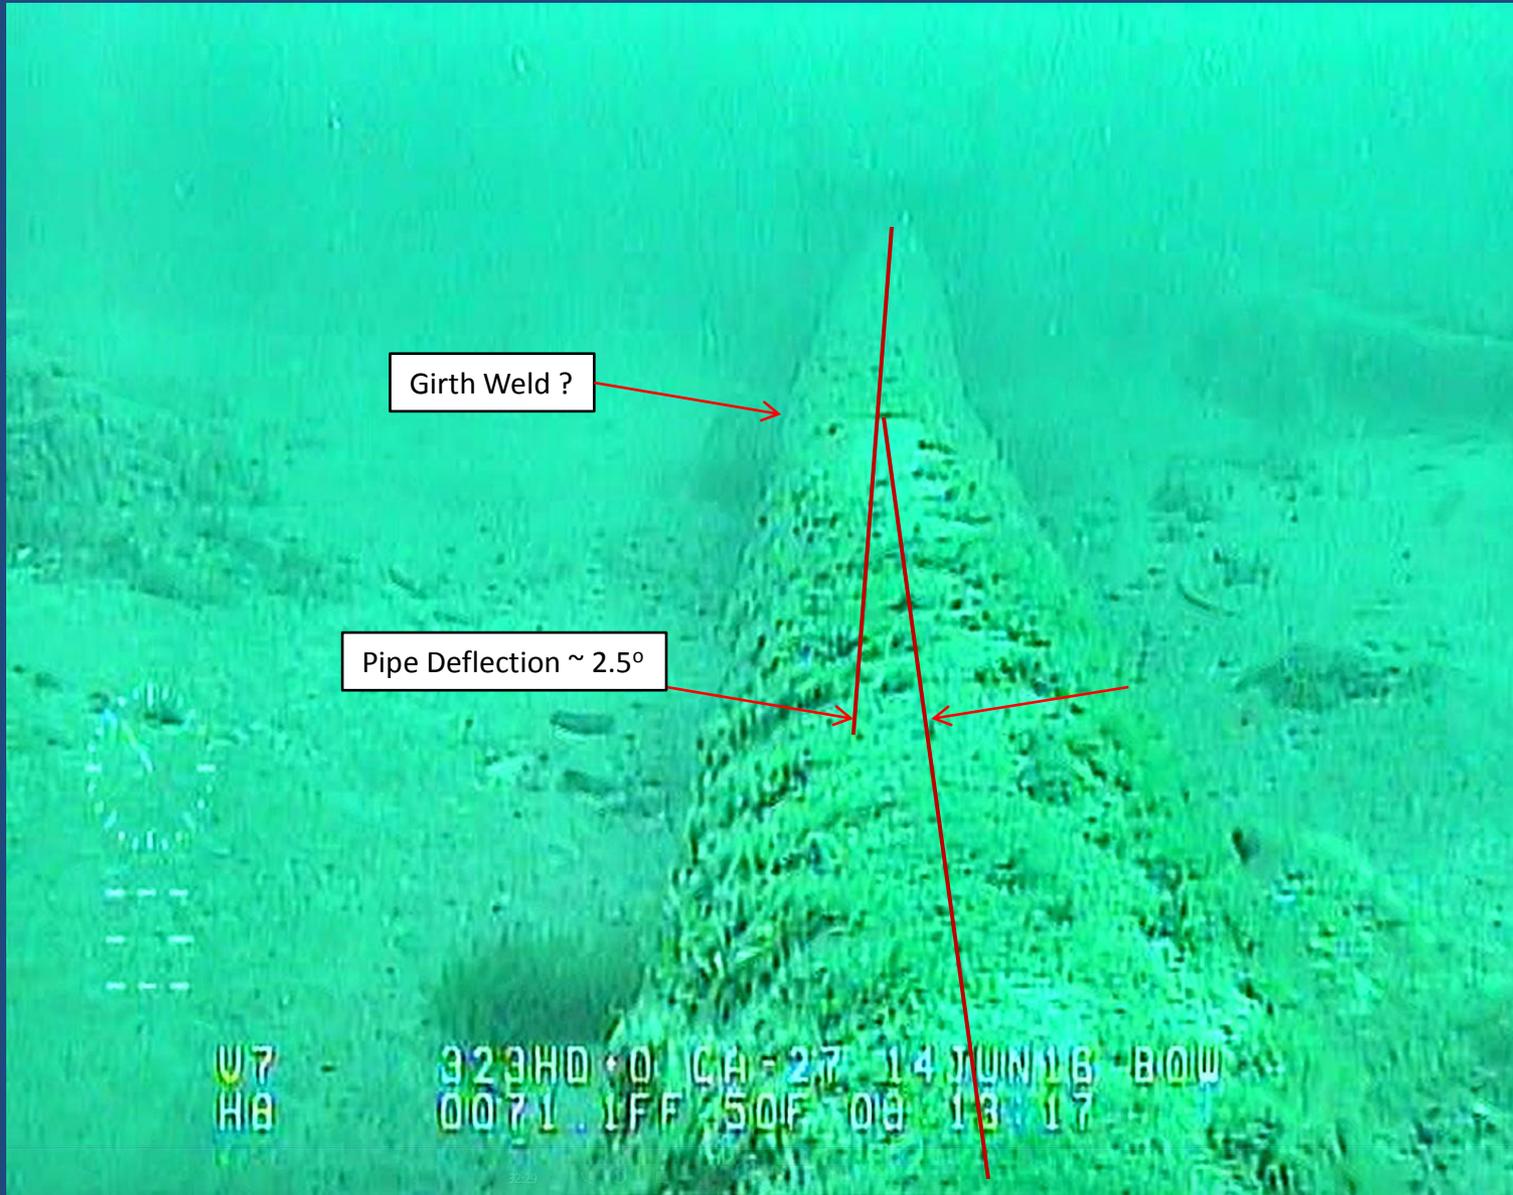
Evidence of Lateral Pipe Movement from 2012 and 2016 Inspection Videos

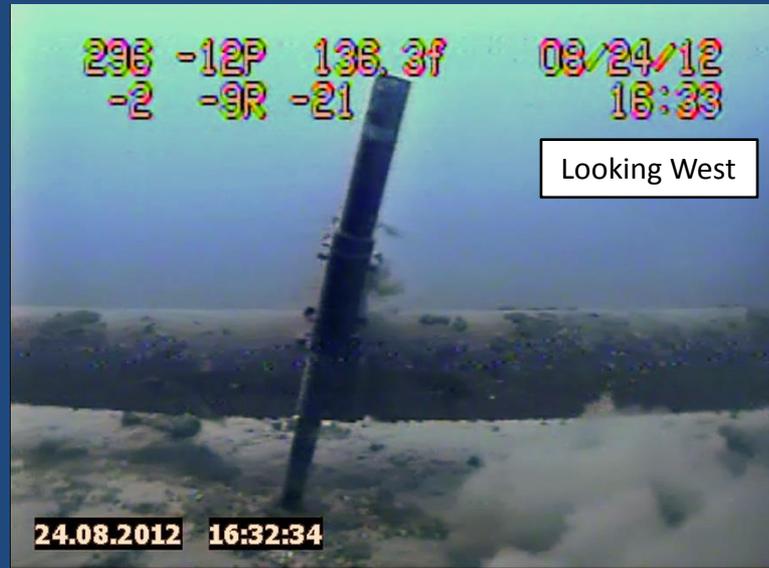
Laterally Deflected Anchor from 2012 Inspection

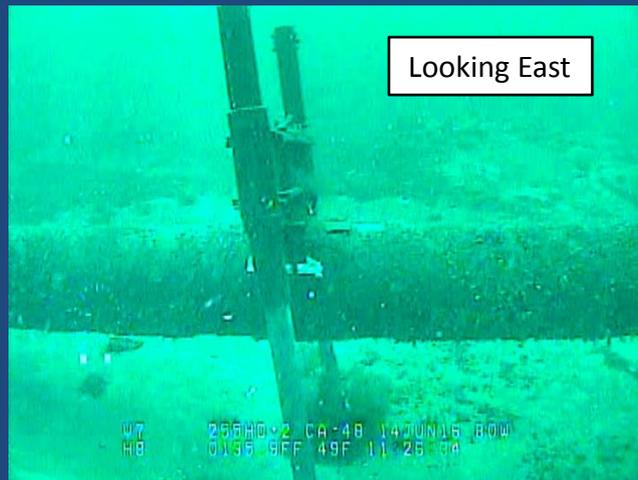
Laterally Deflected Anchor from 2016 Inspection

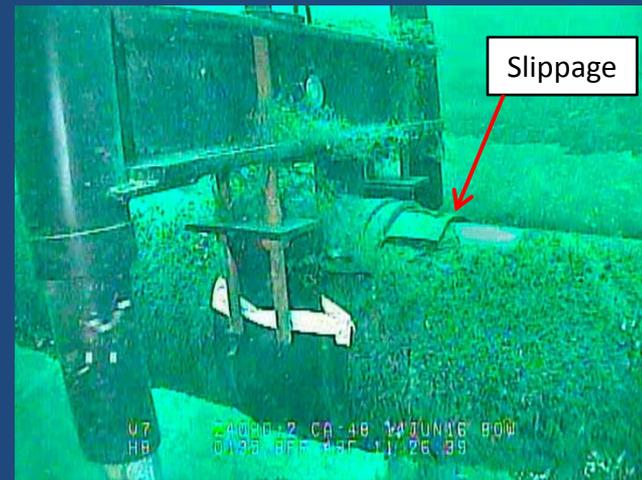
Evidence of Lateral Pipe Slippage through Anchor

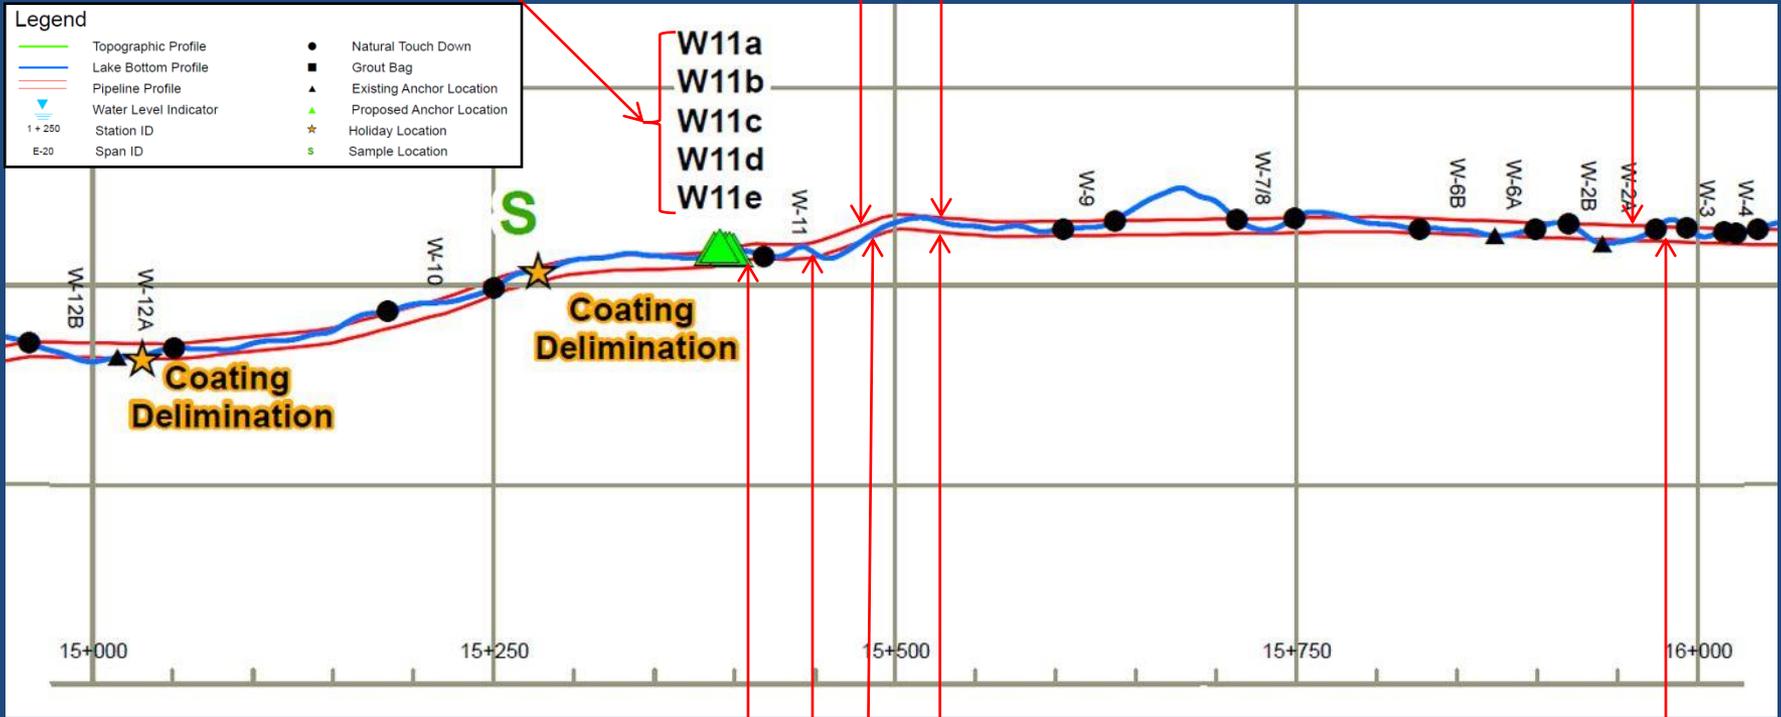
Line 5, West Leg, Pipe Deformities

Location of Bent Pipe in Video

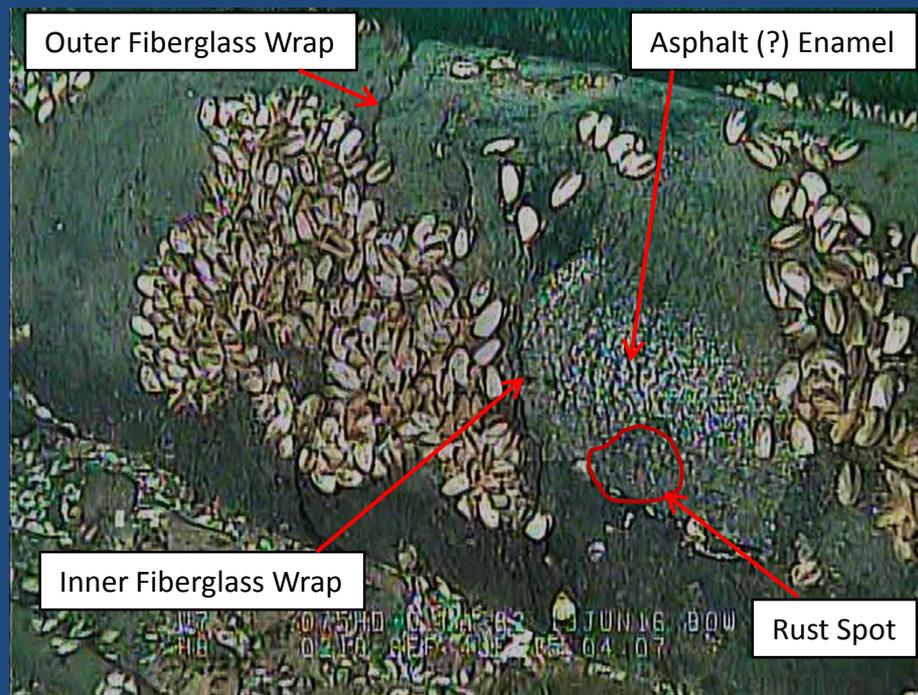
Current Induced Peeling of Protective Fiberglass Wrap
