## Zebra and Quagga Mussels and their Impact on Bare Steel

Gary Street, M.S., P.E.

October 27, 2017

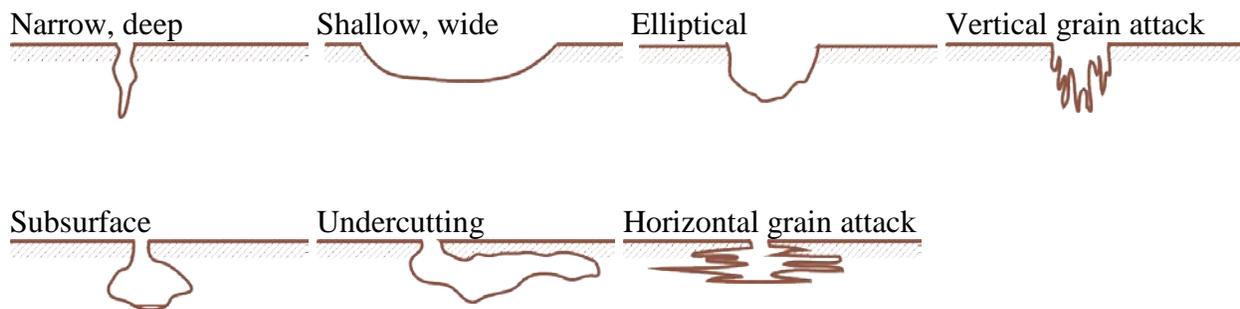
*“Pitting is considered to be more dangerous than uniform corrosion damage because it is more difficult to detect, predict and design against. Corrosion products often cover the pits. A small, narrow pit with minimal overall metal loss can lead to the failure of an entire engineering system.”*

**Typical examples of pitting corrosion are shown below:**<sup>14</sup>

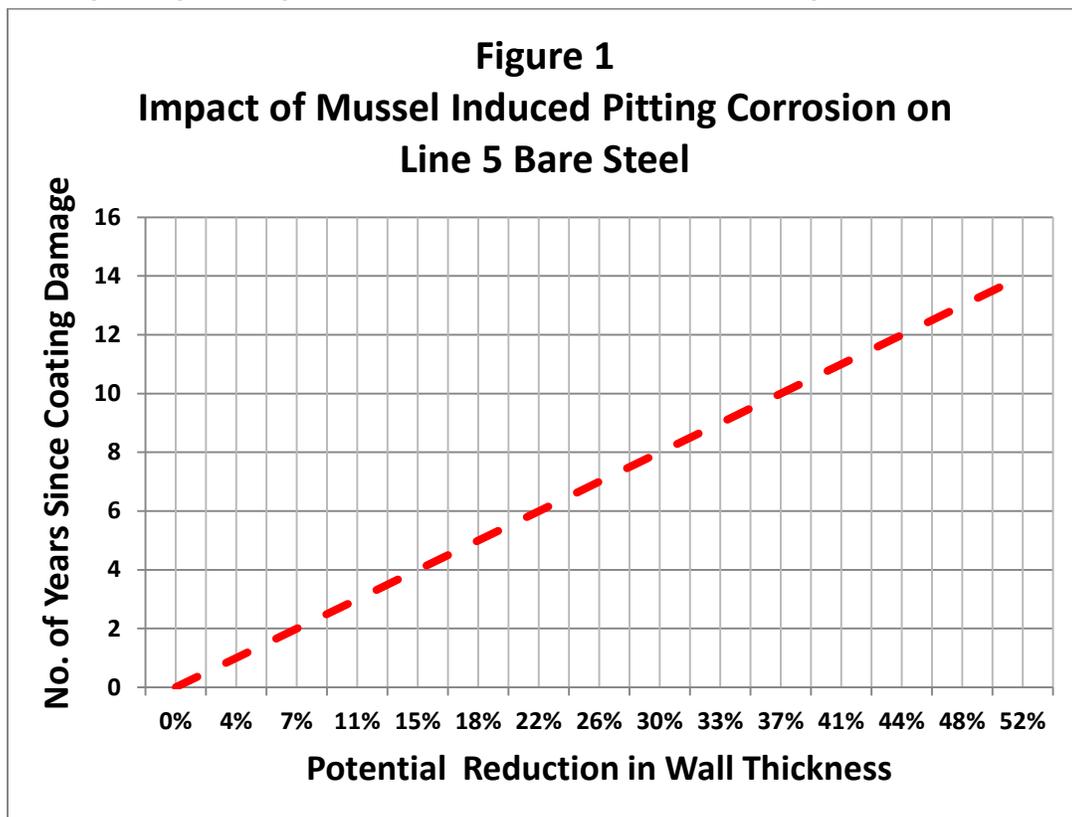
30 mpy = 30/1000 inches per year = 0.03 inches per year  
For 14 years, this amounts 0.03\*14 = 0.42 inches of pitting corrosion.

**Probable wall thickness in 2017 due to pitting corrosion since 2003 = (0.812-0.42) = 0.392 inches.**

To say it another way, where pitting corrosion due to the impact of zebra mussels on bare steel has occurred, **the wall of the pipeline may be only 48% as thick as it was in 1953 when it was originally installed.**

Figures 1 & 2 portray the impact of corrosion on bare steel caused by mussels.

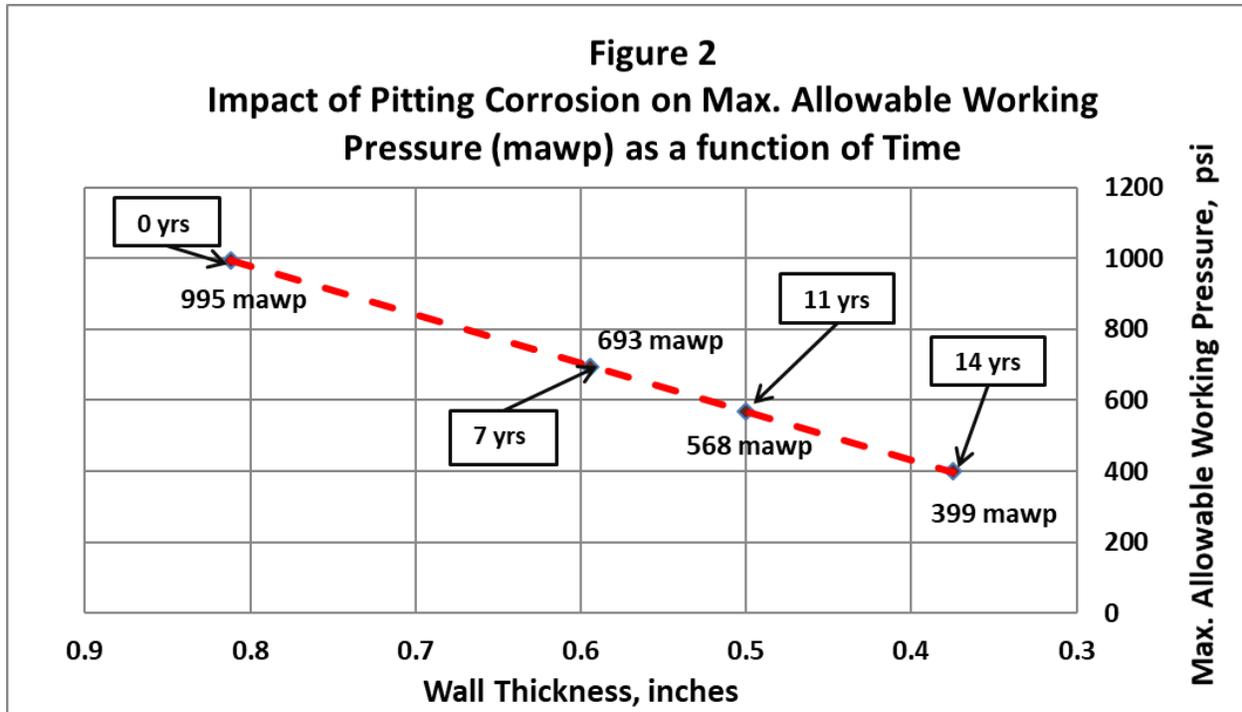
Figure 2 is a plot of Maximum Allowable Working Pressure (mawp) for schedule 60, 20 inch outside diameter, seamless carbon steel pipe.<sup>19</sup> This is the pipe that was installed at the Straits of Mackinac in 1953.

For example, the chart tells us that in 7 years, pitting corrosion will cause the MAWP to decrease from 995 psi to 693 psi; in 14 years (the period of time from 2003 to 2017), the MAWP can decrease to 399 psi.

Figure 2 assumes that pitting corrosion did not occur prior to 2003. Enbridge has recently admitted that damage has occurred to the pipeline coating while the new supports were being installed.<sup>20</sup> They apparently have been aware of this since 2014, but only recently acknowledged it. While Enbridge claims to have discovered the damage in 2014, we do not know when it actually occurred, so have assumed that at least some of the damage to the coating took place in 2003.
